**Flood Control Project Maintenance  
Levee Inspections**

## Maintenance Issue Types Only, Levee Inspection Report By Mile - Spring 2019

### Butte County Department of Public Works

| Waterway | Bank | Unit Miles | Inspection Start/End | Inspector |
|---|---|---|---|---|
| Unit No. 01 Mud Creek | Right | 6.80 | 04/10/2019<br>04/10/2019 | Makar<br>Sokol |

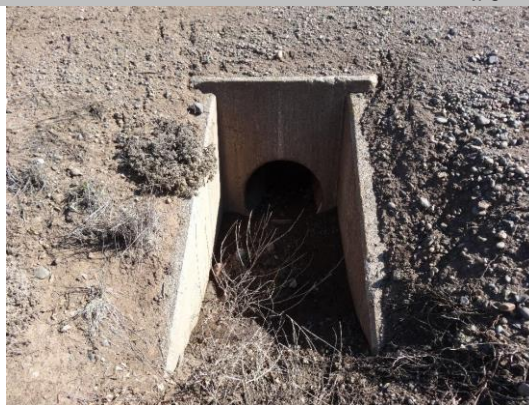
Photo 2 of 2 : UCIP\_SP\_2019\_30294\_55703.jpg

| FS_ID:30294<br>DS_ID:19216<br>EP_NO: N/A<br>Repair Type: Non-Urgent<br>Crossing Status: Found<br>UCIP Comments: Inlet and outlet needs cleaning and clearing of debris.<br>FIELD_STRUCT_DESC: 24-inch corrugated metal gravity drainage pipe through the levee, 8.5 feet below the crown. Flap gate on the waterside (WS) end. Concrete U-shaped headwall on each end. Grouted riprap apron on the landside (LS) end. Grouted riprap spillway on the WS end.<br>[Additional Reference(s): DWR Levee Log, 1992. USACE Sacramento O&M Manual 504, May 1965, (HLM 3.11)].<br>FS Date: 2/20/2014 | | | | | | |

LS view: U type concrete headwall and CMP on levee slope. Debris blocking the inlet pipe.

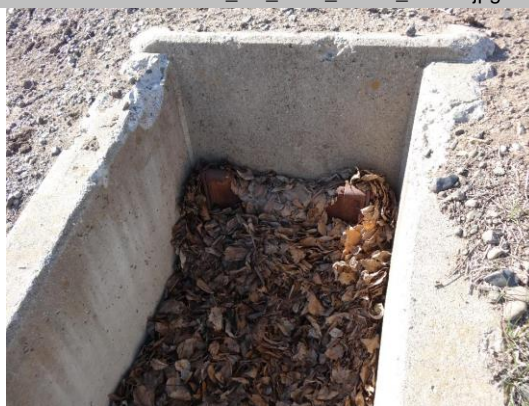
Photo 1 of 2 : UCIP\_SP\_2019\_30295\_55706.jpg

| FS_ID:30295<br>DS_ID:19217<br>EP_NO: N/A<br>Repair Type: Non-Urgent<br>Crossing Status: Found<br>UCIP Comments: It needs cleaning and clearing in inlet and outlet ends.<br>FIELD_STRUCT_DESC: 24-inch corrugated metal gravity drainage pipe through the levee, 9 feet below the crown. Flap gate on the waterside (WS) end. Concrete U-shaped headwall on each end. Grouted riprap apron on the landside (LS) end. Grouted riprap spillway on the WS end.<br>[Additional Reference(s): DWR Levee Log, 1992. USACE Sacramento O&M Manual 504, May 1965, (HLM 3.27)].<br>FS Date: 2/20/2014 | | | | | |

WS view: U type concrete headwall, flapgate on levee slope. Vegetation debris blocking the outlet.

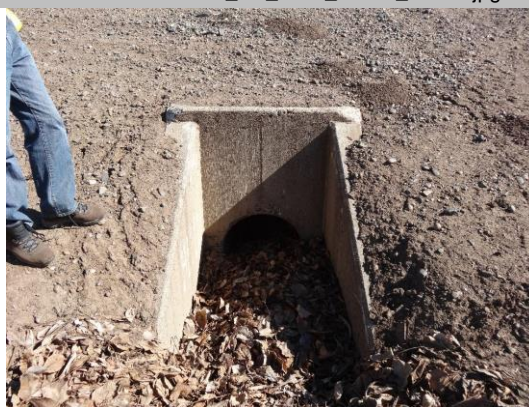
Photo 2 of 2 : UCIP\_SP\_2019\_30295\_55705.jpg

LS view: U type concrete headwall and CMP on levee slope. Vegetation debris blocking the inlet.

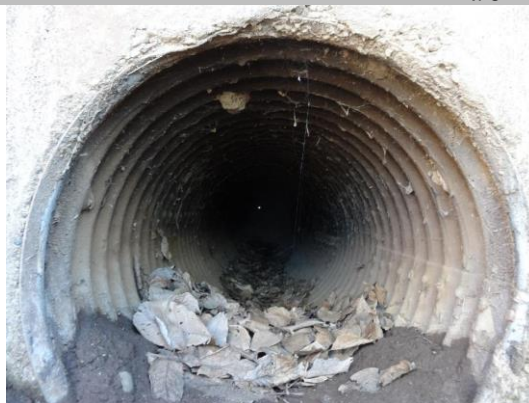
Photo 3 of 3 : UCIP\_SP\_2019\_30310\_55739.jpg

| FS_ID:30310<br>DS_ID:19218<br>EP_NO: N/A<br>Repair Type: Non-Urgent<br>Crossing Status: Found<br>UCIP Comments: Needs cleaning and clearing of debris.<br>FIELD_STRUCT_DESC: 24-inch corrugated metal gravity drainage pipe through the levee, 10 feet below the crown. Flap gate on the waterside (WS) end. Concrete U-shaped headwall on each end. Grouted riprap apron on the landside (LS) end. Grouted riprap spillway on the WS end. [Additional Reference(s): DWR Levee Log, 1992. USACE Sacramento O&M Manual 504, May 1965, (HLM 3.48)].<br>FS Date: 2/20/2014 | | | | | | |

LS view: inside view of CMP on levee slope. Needs cleaning and clearing.

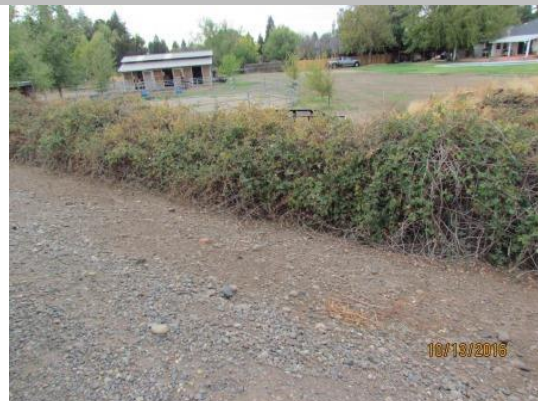
Photo 1 of 1 : SP\_2019\_NA0003\_64\_22\_20190325\_00005.jpg

View of the blackberries blocking visibility and access.

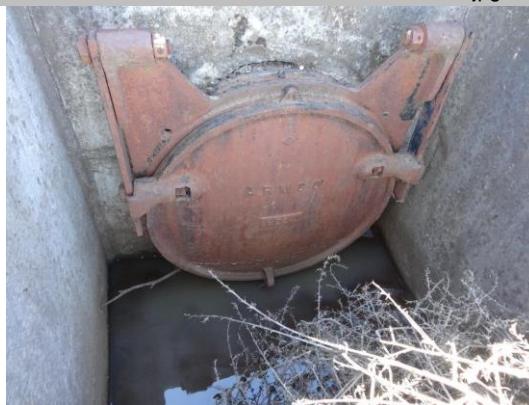
Photo 2 of 3 : UCIP\_SP\_2019\_31667\_57967.jpg

WS view: U type concrete headwall, pipe, and flapgate on levee slope. Vegetation debris on outlet box.

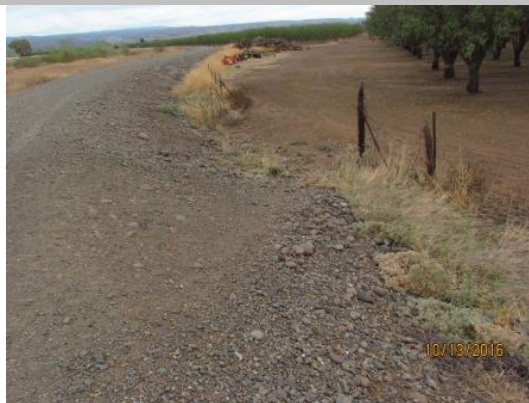
Photo 1 of 1 : SP\_2019\_NA0003\_65\_29\_20190325\_00005.jpg

View of the slope instability caused by vehicles along the landside slope.

| S3 : Repair the levee slope damaged by vehicle traffic and prevent access where possible. | | | | | |

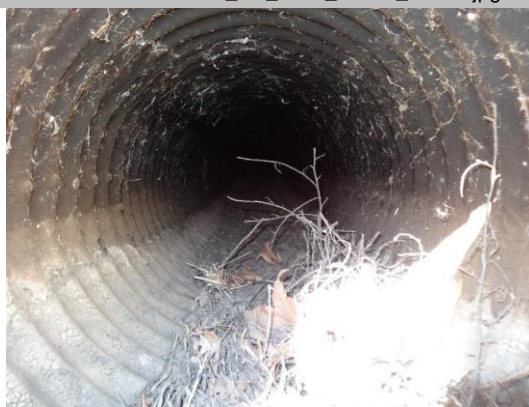
Photo 3 of 3 : UCIP\_SP\_2019\_30403\_55920.jpg

| FS_ID:30403<br>DS_ID:19235<br>EP_NO: N/A<br>Repair Type: Non-Urgent<br>Crossing Status: Found<br>UCIP Comments: Needs cleaning and clearing of debris.<br>FIELD_STRUCT_DESC: 24-inch corrugated metal gravity drainage pipe through the levee, 12.5 feet below the crown. Flap gate on the waterside (WS) end. Concrete U-shaped headwall on each end. Grouted riprap apron on the landside (LS) end. Grouted riprap spillway on the WS end. [Additional Reference(s): DWR Levee Log, 1992. USACE Sacramento O&M Manual 504, May 1965, (HLM 1.34)].<br>FS Date: 2/24/2014 | | | | | | |

LS view: inside view of CMP on levee slope. Needs cleaning and clearing.

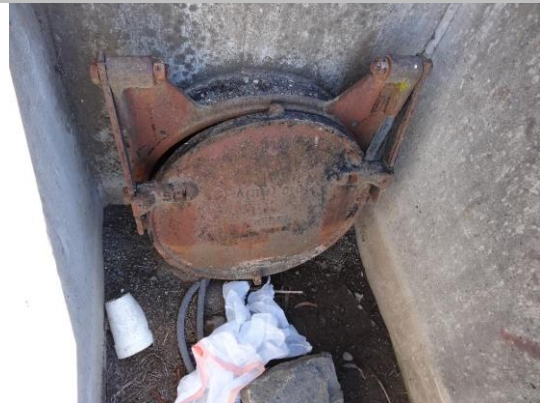
Photo 1 of 2 : UCIP\_SP\_2019\_30743\_56641.jpg

WS view: U type concrete headwall, pipe, and flapgate on levee slope.  
Debris in outlet box.

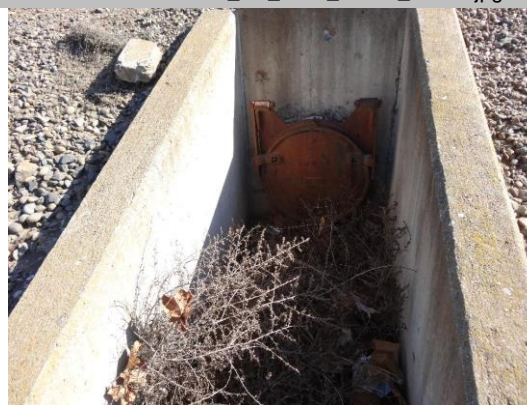
Photo 1 of 3 : UCIP\_SP\_2019\_30763\_56662.jpg

WS view: U type concrete headwall, pipe, and flapgate on levee slope.  
Vegetation debris blocking outlet.

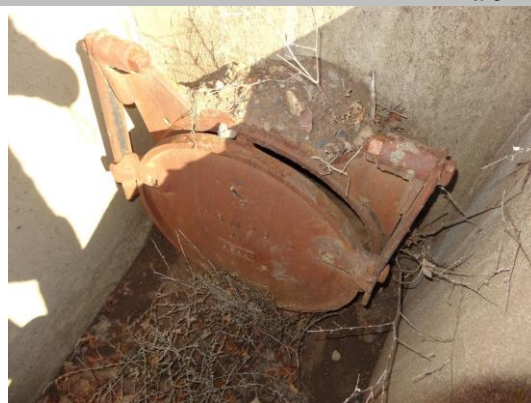
Photo 1 of 3 : UCIP\_SP\_2019\_30783\_56682.jpg

WS view: U type concrete headwall, pipe, and flapgate on levee slope.  
Gate not fully closed. Debris and soil in outlet box.

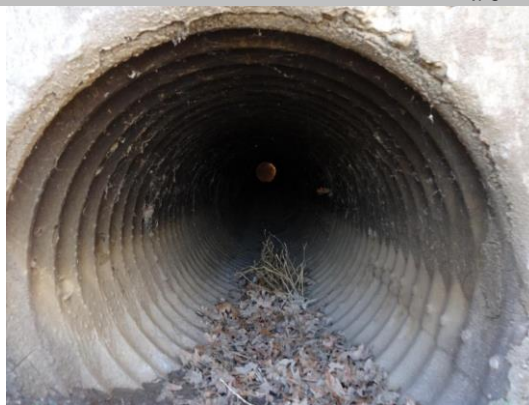
Photo 3 of 3 : UCIP\_SP\_2019\_30783\_56680.jpg

LS view: inside view of CMP on levee slope. Needs cleaning and clearing.

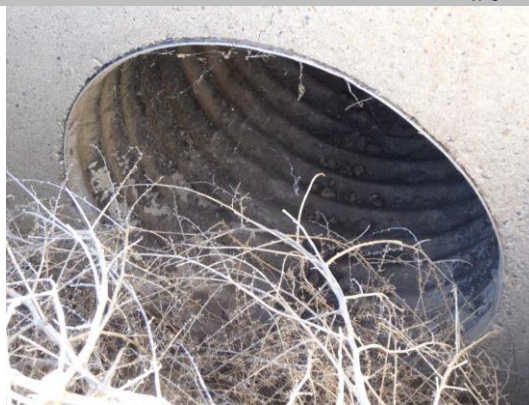
Photo 3 of 3 : UCIP\_SP\_2019\_30803\_56683.jpg

LS view: inside view of CMP on levee slope. Needs cleaning and clearing.

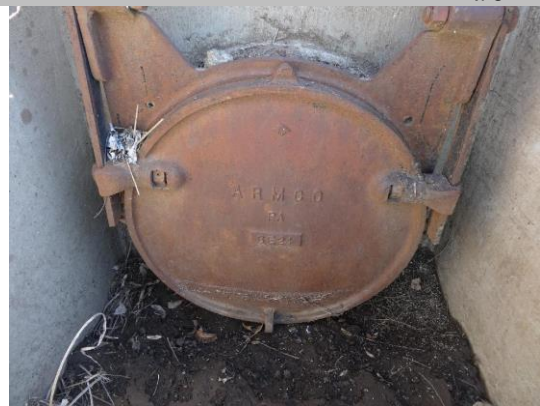
Photo 1 of 3 : UCIP\_SP\_2019\_31028\_56913.jpg

WS view: U type concrete headwall, pipe, and flapgate on levee slope.  
Soil/mud on outlet box.

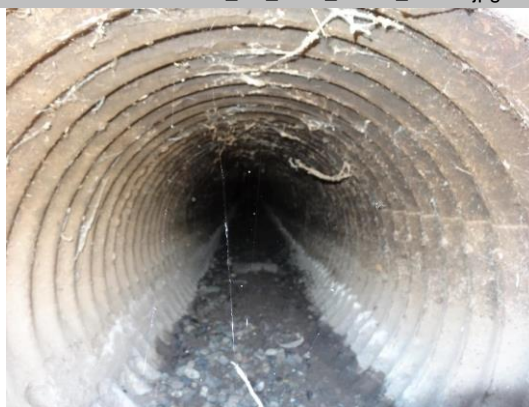
Photo 3 of 3 : UCIP\_SP\_2019\_31028\_56911.jpg

LS view: inside view of CMP on levee slope. Needs cleaning and clearing.

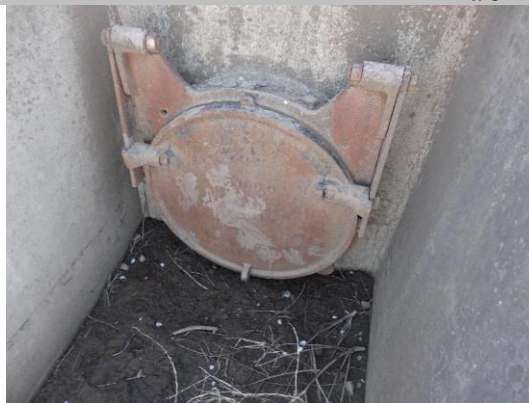
Photo 1 of 3 : UCIP\_SP\_2019\_31031\_56917.jpg

WS view: U type concrete headwall, pipe, and flapgate on levee slope. Soil/mud on outlet box.

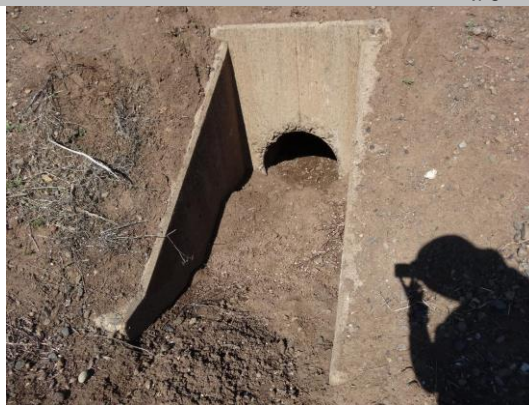
Photo 2 of 3 : UCIP\_SP\_2019\_31031\_56916.jpg

LS view: U type concrete headwall and CMP on levee slope. Soil/mud on inlet box.

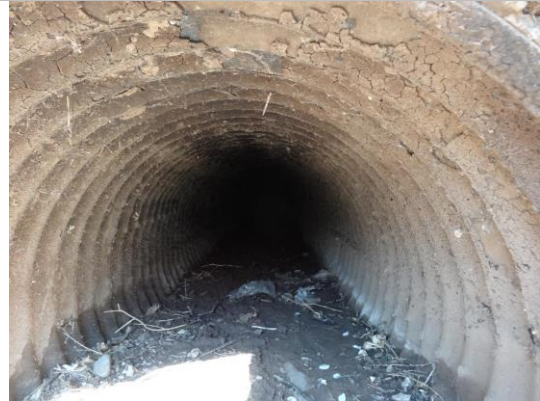
Photo 3 of 3 : UCIP\_SP\_2019\_31031\_56915.jpg

LS view: inside view of CMP on levee slope. Needs cleaning and clearing.

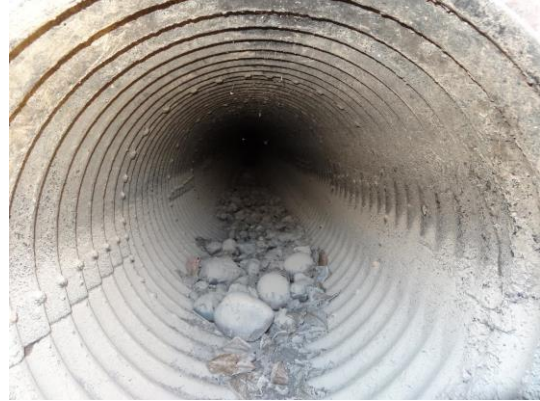
Photo 3 of 3 : UCIP\_SP\_2019\_31085\_56986.jpg

LS view: inside view of CMP on levee slope. Needs cleaning and clearing.

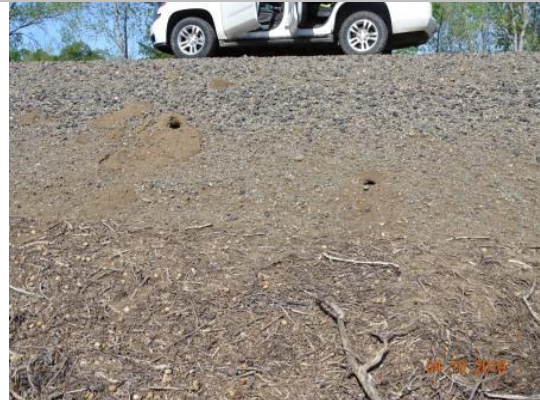
Photo 1 of 1 : SP\_2019\_NA0003\_65\_45\_20190415\_00066.jpg

View of the rodent holes on the landside slope. Spring 2019.

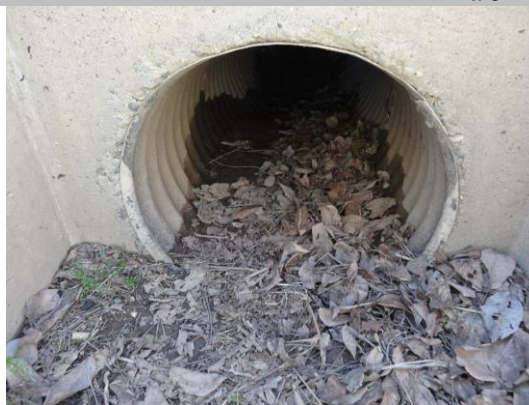
Photo 2 of 2 : UCIP\_SP\_2019\_31129\_57035.jpg

LS view: U type concrete headwall and CMP on levee slope. Soil/mud and vegetation on inlet box.

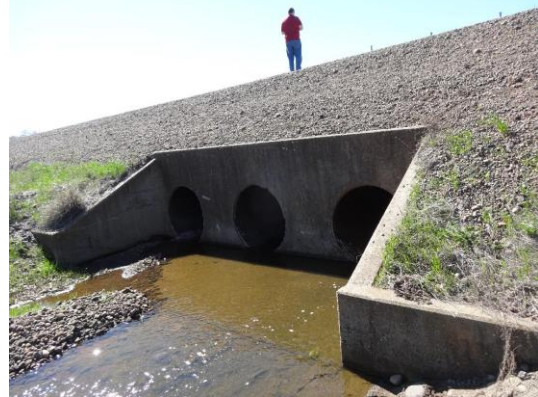
Photo 2 of 2 : UCIP\_SP\_2019\_32104\_58605.jpg

LS view: U type concrete headwall and three CMPs on levee slope. Soil/mud on inlet box.

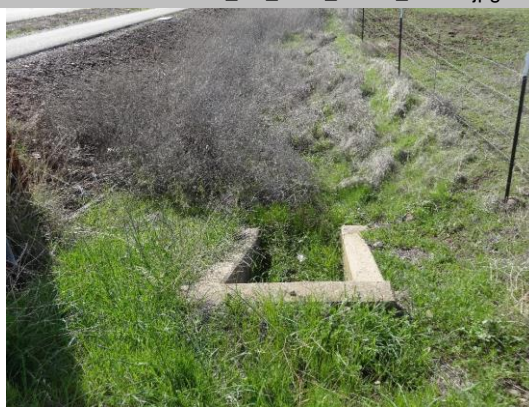
Photo 2 of 3 : UCIP\_SP\_2019\_32124\_58624.jpg

LS view: U type concrete headwall of CMP culvert on levee slope.  
Vegetation on inlet box.

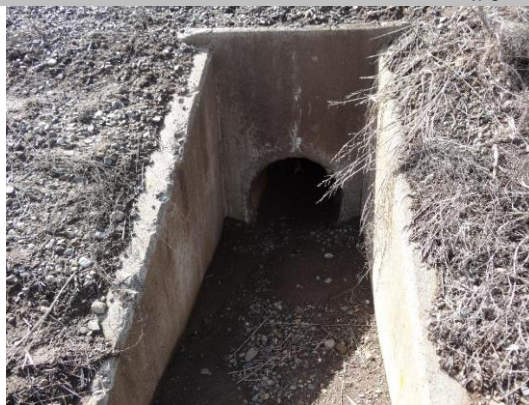
Photo 2 of 3 : UCIP\_SP\_2019\_31901\_58193.jpg

LS view: U type concrete headwall and CMP on levee slope. Soil/mud on inlet box.

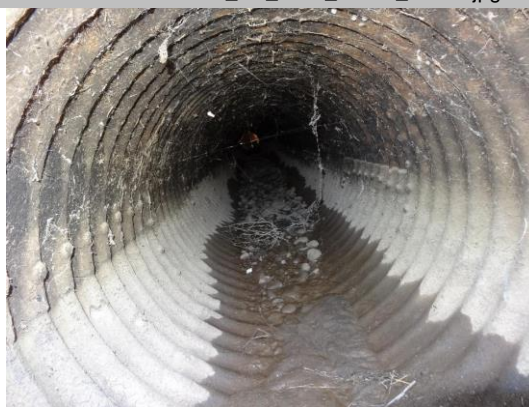
Photo 3 of 3 : UCIP\_SP\_2019\_31864\_58067.jpg

LS view: inside view of CMP on levee slope. Needs cleaning and clearing.

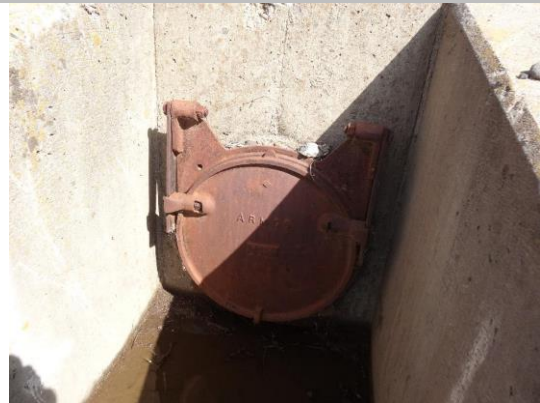
Photo 1 of 3 : UCIP\_SP\_2019\_31856\_58053.jpg

WS view: U type concrete headwall, pipe, and flapgate on levee slope.  
Soil/mud on outlet box.

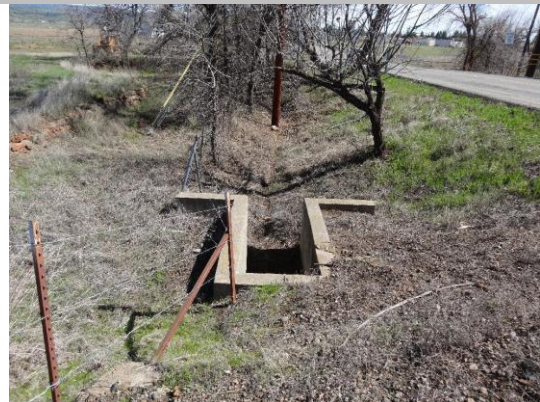
Photo 3 of 3 : UCIP\_SP\_2019\_32025\_58510.jpg

LS view: U type concrete headwall and CMP on levee slope. Vegetation debris and mud on inlet box.

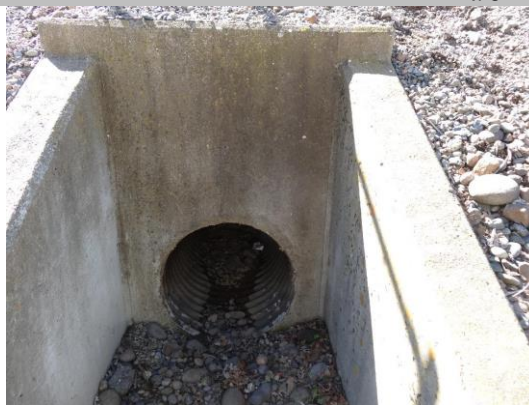
Photo 2 of 3 : UCIP\_SP\_2019\_32023\_58504.jpg

LS view: U type concrete headwall and CMP on levee slope. Pebbles and mud on inlet box.

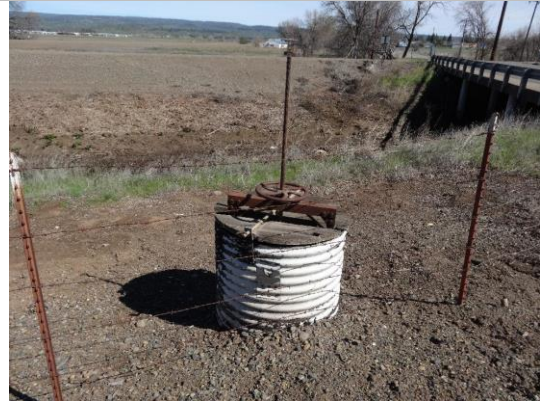
Photo 3 of 3 : UCIP\_SP\_2019\_32144\_58642.jpg

WS view: slide gate in CMP riser on waterside. No access to CMP riser.

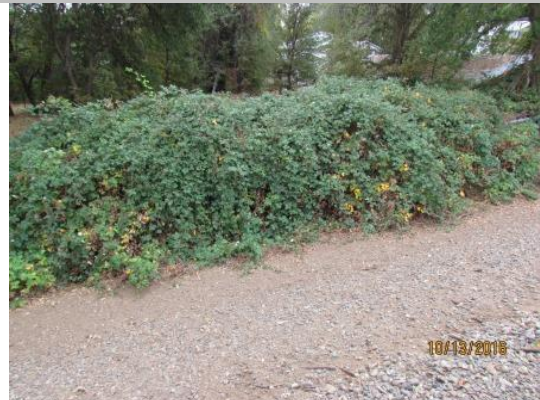
Photo 1 of 1 : SP\_2019\_NA0003\_68\_23\_20190325\_00007.jpg

View of the blackberries blocking visibility and access.

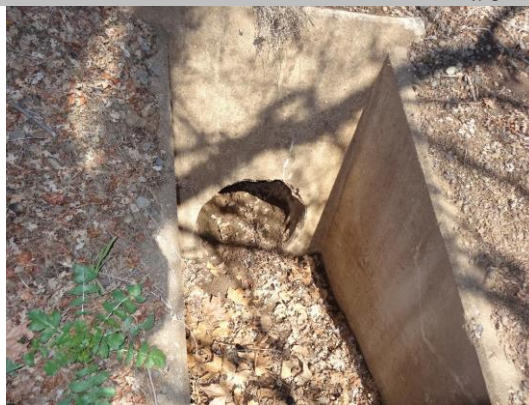
Photo 2 of 3 : UCIP\_SP\_2019\_31963\_58383.jpg

LS view: U type concrete headwall and CMP on levee slope. Vegetation debris and mud on inlet box.

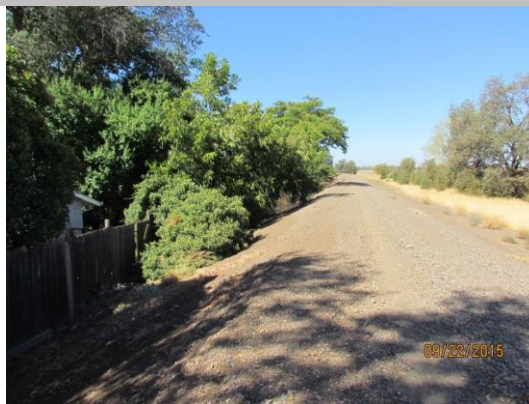
Photo 1 of 1 : SP\_2019\_NA0003\_68\_17\_20190325\_00004.jpg

View of the trees overhanging the levee slope.

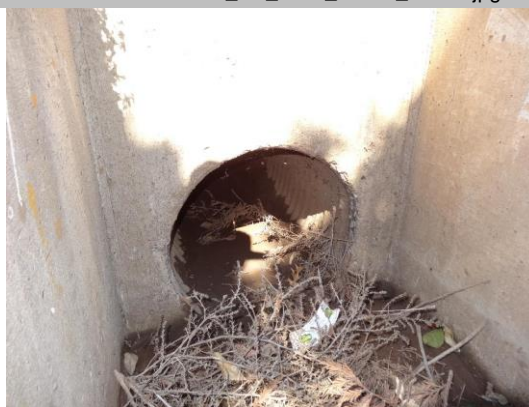
Photo 2 of 2 : UCIP\_SP\_2019\_31964\_58388.jpg

LS view: U type concrete headwall and CMP on levee slope. Vegetation debris and mud in inlet box.

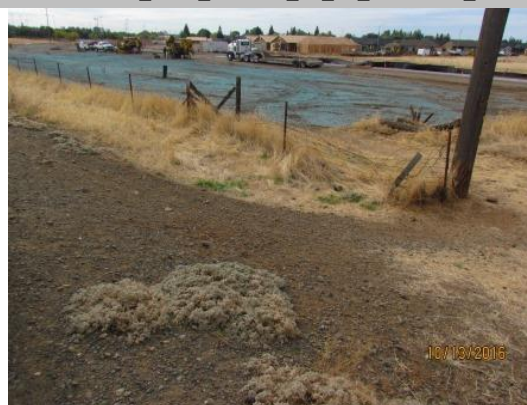
Photo 1 of 1 : SP\_2019\_NA0003\_69\_13\_20190325\_00002.jpg

View of the damaged slope by foot traffic.
